TEST REPORT

Sample: Planter Eco
Logicbase V-SL

Determination of root puncture resistance

Determination of resistance to root according to CEN/TS 14416

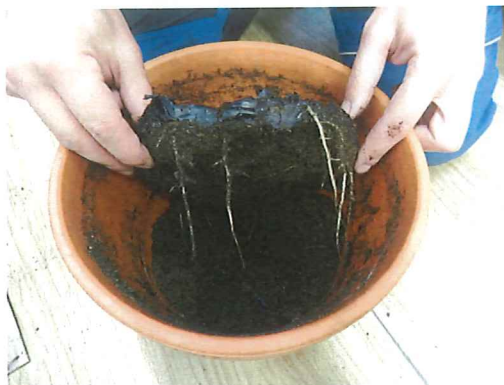
Photo No. 1 - Control of the vitality of the plants – The roots penetrated bitumen layer

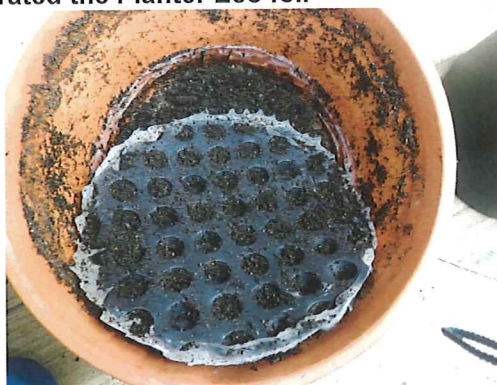
Photo No. 2 and 3 – The roots have not penetrated the Planter Eco foil

Characteristics measured	Unit	Test results
Roots puncture	-	The roots have not penetrated the samples

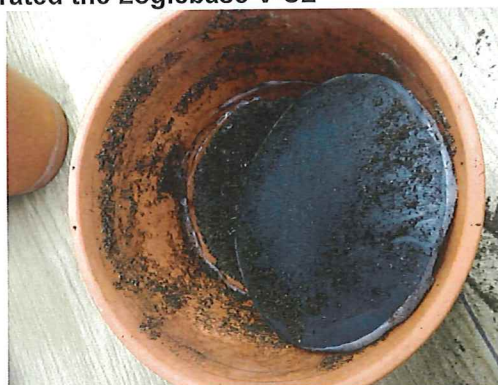
Photo No. 4 and 5 – The roots have not penetrated the Logicbase V-SL

Characteristics measured	Unit	Test results
Roots puncture	-	The roots have not penetrated the samples
